Report
Rapport LTR-FR-185

**Dash 8 Aircraft Braking Performance
on Winter Contaminated Runways**

Also published as Transport Canada publication no. TP13957E

Auteur(s) M.Bastian, J.B. Croll

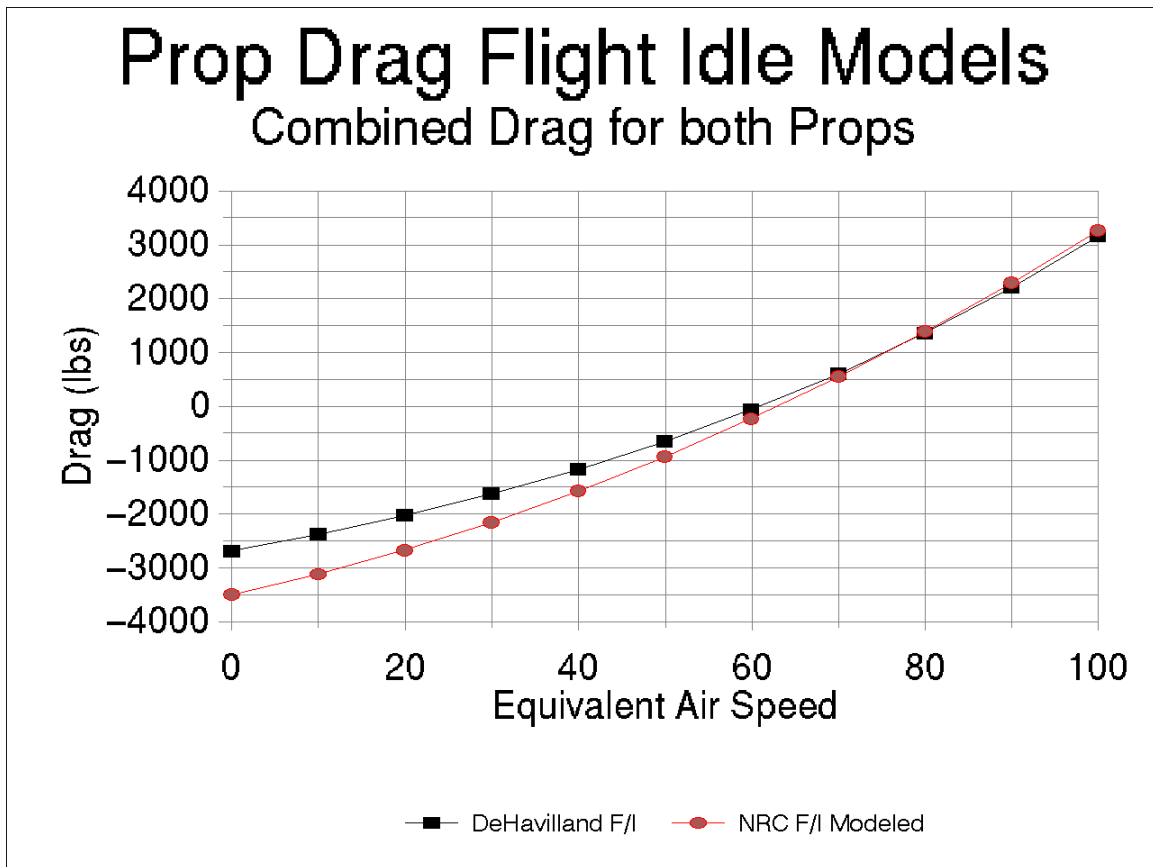
Figure 1 and Figure 2 contrast the experimentally derived propeller drag models with the drag models supplied by DeHavilland. Both the flight idle and discing derived models differ only slightly from the aircraft manufacturer's models. At the higher speeds (roughly 60 to 100 knots) the DeHavilland model matches very closely to the experimentally derived models. At the lower speeds the experimentally derived model under estimates the drag by up to about 800 lbs. This is true for both the flight idle and discing drag models. The most plausible explanation for the slight divergence in the models, is that the DeHavilland models contain solely propeller drag and, the derived models contain a number of additional factors that are all lumped together and labeled "propeller drag". The dominant of the all these combined factors would be the residual idle thrust from the engines. Another possible reason for the difference in the models is that the manufacturer must, by necessity, be conservative in its determination of the propeller drag. Therefore, the slight divergence between the DeHavilland and the experimentally derived models of propeller drag is not of concern. The experimentally derived models were used for the subsequent data reduction.

shows the relationship between the equivalent air speed and the propeller discing drag. A second order equation was also found to best fit the data, with the coefficients shown on the graph. Note that the drag term is slightly negative at zero ground speed.

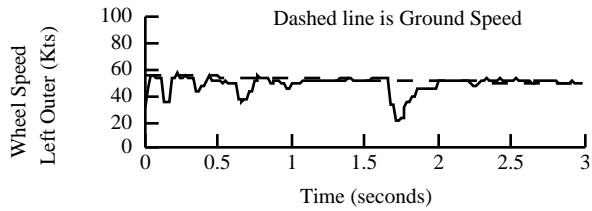
Flight 2001/05, Run Number 4

Configuration: Flaps 15, Flight Idle, Max Braking

CRFI Average 0.30

Surface: Wet snow and slush over ice patches and bare pavement
20-40% water puddles 1.5-2.5" deep

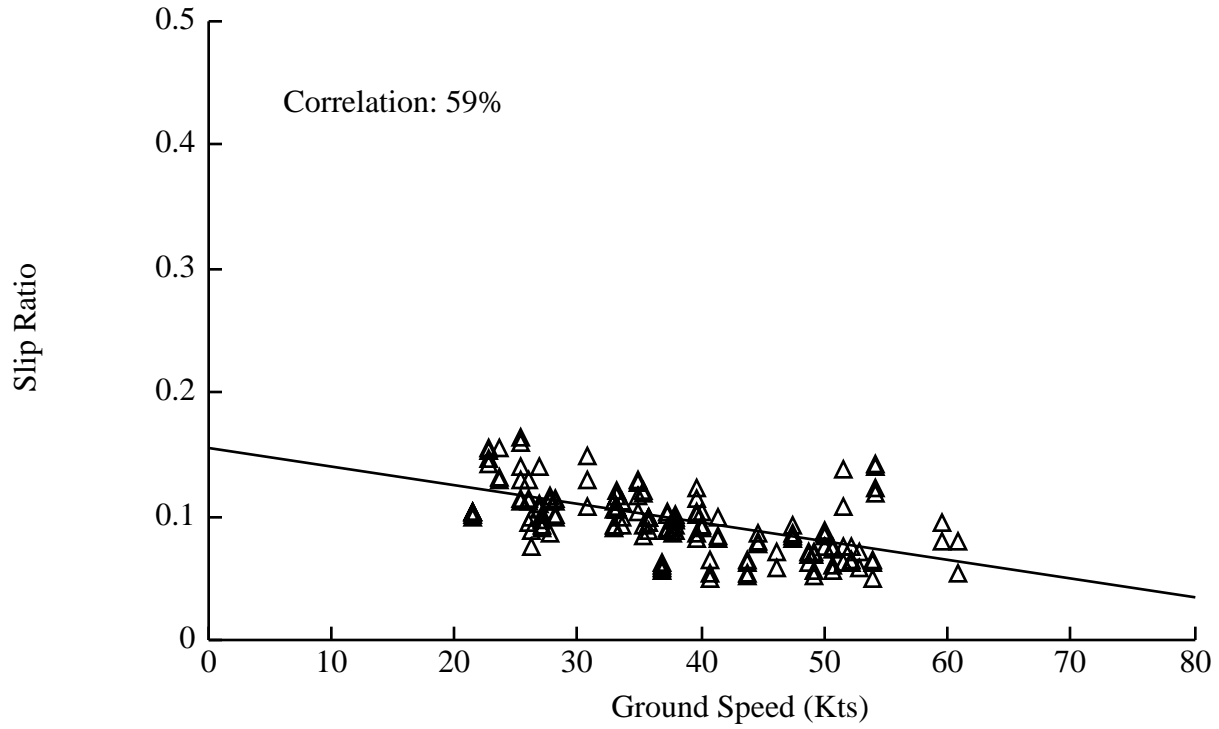
Slip Ratio versus Ground Speed

$$\text{Slip Ratio} = 0.155 - 0.0015 * \text{Ground Speed}$$

The relationship of the slip ratio and the ground speed is shown in Appendix C, Page C49. This graph plots the average slip ratio against the average ground speed for a given test run. There appears to be a significant effect of ground speed on the slip ratio, namely, that as the ground speed increase the slip ratio will tend to decrease slightly. A linear correlation of 59% was observed between the two. It is not clear if this relationship is a

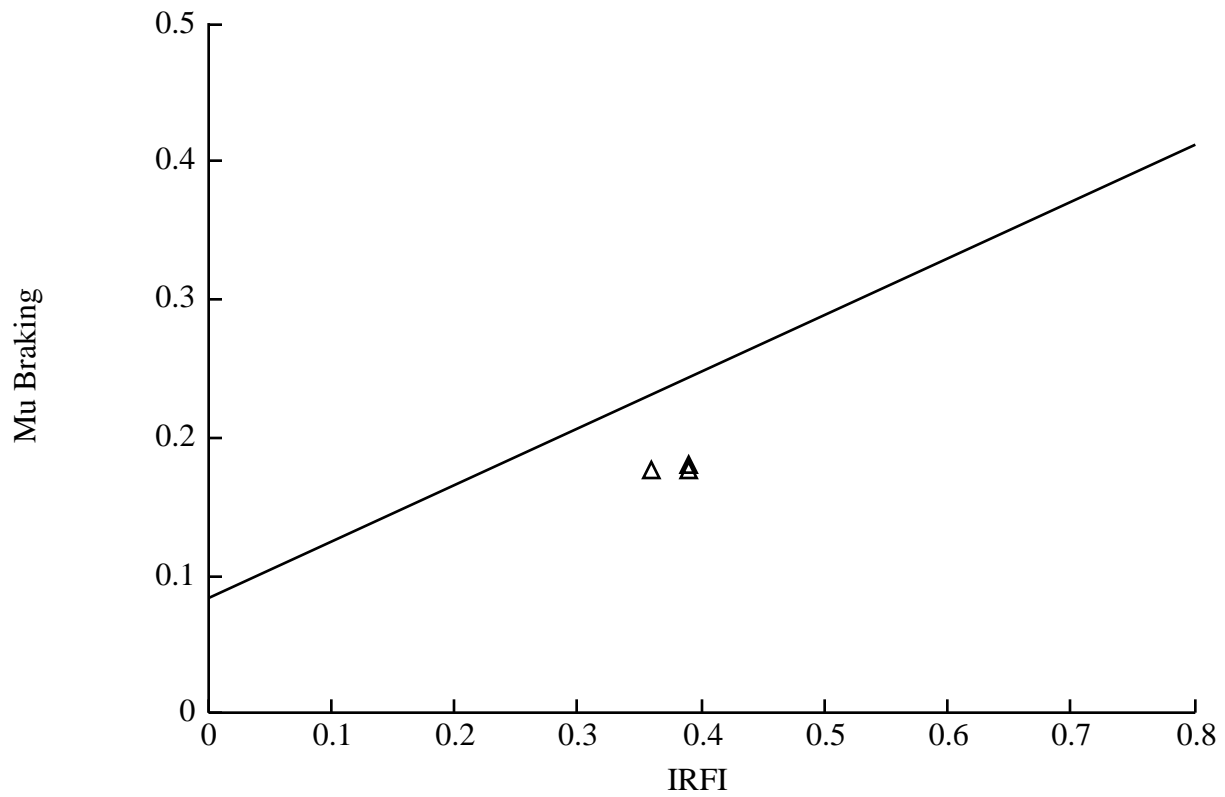
From Appendix D Page D21

$$\text{Mu Braking} = 0.05921 + 0.3676 * \text{IRFI}$$
